Issue 310 | March 2023

# The Brutal Reality of Hock Fractures in Racing Greyhounds

Introducing Radiographic Guidelines for the Early Warning of Impending Fracture

Dr David H Larratt BVSc., IVAS

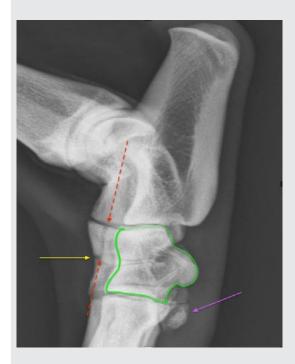
Α

# Dorsal fracture line seen on Medio-dorsal radiograph

**Red arrows** point to the non-displaced Type I dorsal fracture line of the CTB.

**Yellow arrow** points to a black zone at the base of the fracture line which may indicate pre-existing demineralisation. This area can be difficult to assess due to the overlay of the CTB with T3 and T2.

<u>Note:</u> the complete white contrast in the dorsal (front facing) aspect of the CTB indicates that the inner trabecular pores have been compacted with bone matrix (mineralised) leading to reduced flexibility and blood flow. These factors precede fracture.

The additional longitudinal fracture that runs from dorsal to plantar is along the *Midbody* or *Sagittal Line* and is classified as Type III and IV. Type IV has both Dorsal and Sagittal fractures. The Sagittal fracture is difficult to detect when non-displaced but may be seen on the Plantar-dorsal radiograph. (*Refer to Image B. Figure 6., Pg.9*)

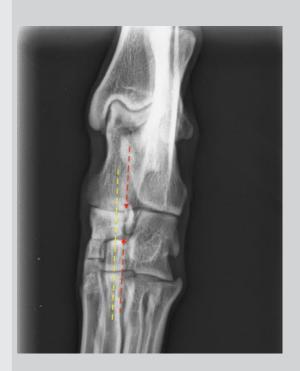
В

# Sagittal fracture line seen on Plantar-dorsal radiograph

**Red arrows** point to the non-displaced Type IV Sagittal fracture line of the CTB.

<u>Note:</u> this dog also had a dorsal fracture line seen on Medio-lateral view).

**Yellow dashed line** on the increased white contrast in the vertically aligned Talus, CTB, T3 and Metatarsal III. This highlights the vertical stress line and the adaption to load by increasing mineralisation in the inner trabeculae of all 4 bones. This is common and highlights why fractures may occur in the CTB, T3 and the underlying Metatarsal III.

<u>Note:</u> the complete white contrast in the bone either side of the fracture line indicates that the inner trabecular bone is compacted leading to reduced flexibility and blood flow. These factors precede fracture.
